Corrosion Assessment Program for Water-Based Fire Sprinkler Systems

What is a Fire Sprinkler System Corrosion Assessment?

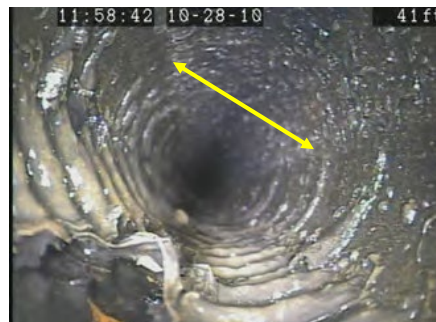
Branch line with significant corrosion deposits, clear air-water interface

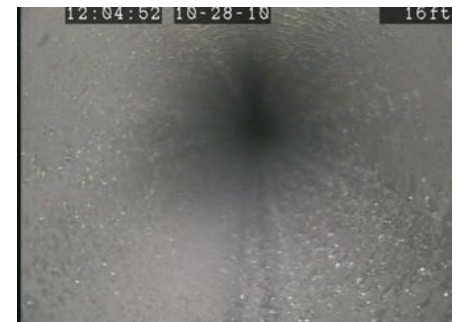
Same branch line with no corrosion, water filled with no air-water interface

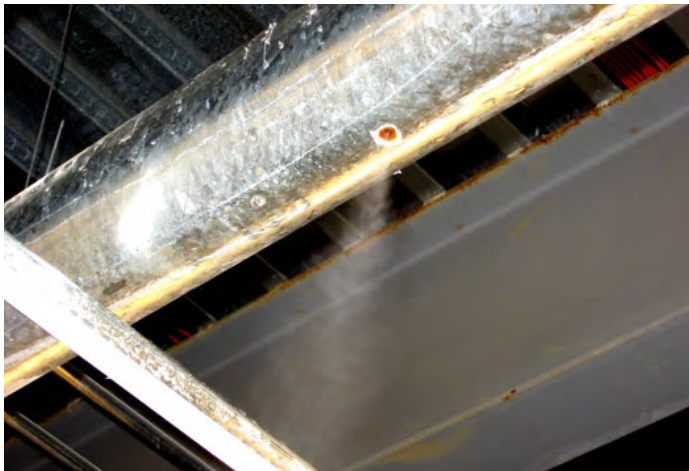
Galvanized Pipe Leak
